2017 PWR ALARA

Water Jet Peening learnings

Presented by: Wolf Creek

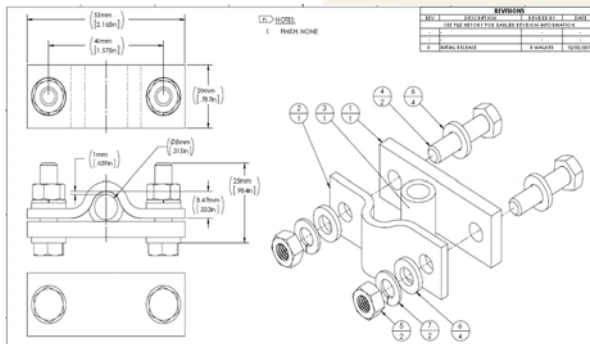
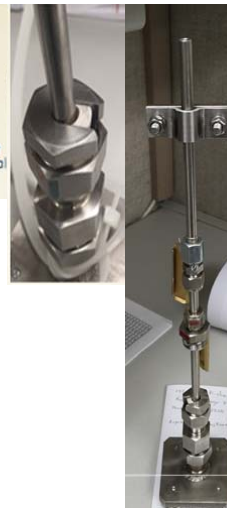
Thimble Tube Clamp Installation after Low Pressure Seals are installed

- Requested video monitoring
- Need to discuss how we will handle potential leaks
- ✓ As you can see from the pictures continuing to tighten the fixture is not going to eliminate the leak as the seal starts to separate from the tubing.

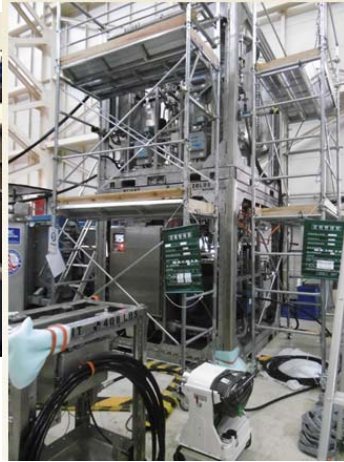
- HPPS has two 50 micron filters shown below.
